Building Infrastructure Testing and Retro-Commissioning

Final Combined Report

Children's Atrium, OU Children's Physician Building, College of Medicine, OU Physician's Building, Garrison Tower, Nicholson Building, Oklahoma Transplant Center and Samis Education Center

Project No. FA20P031

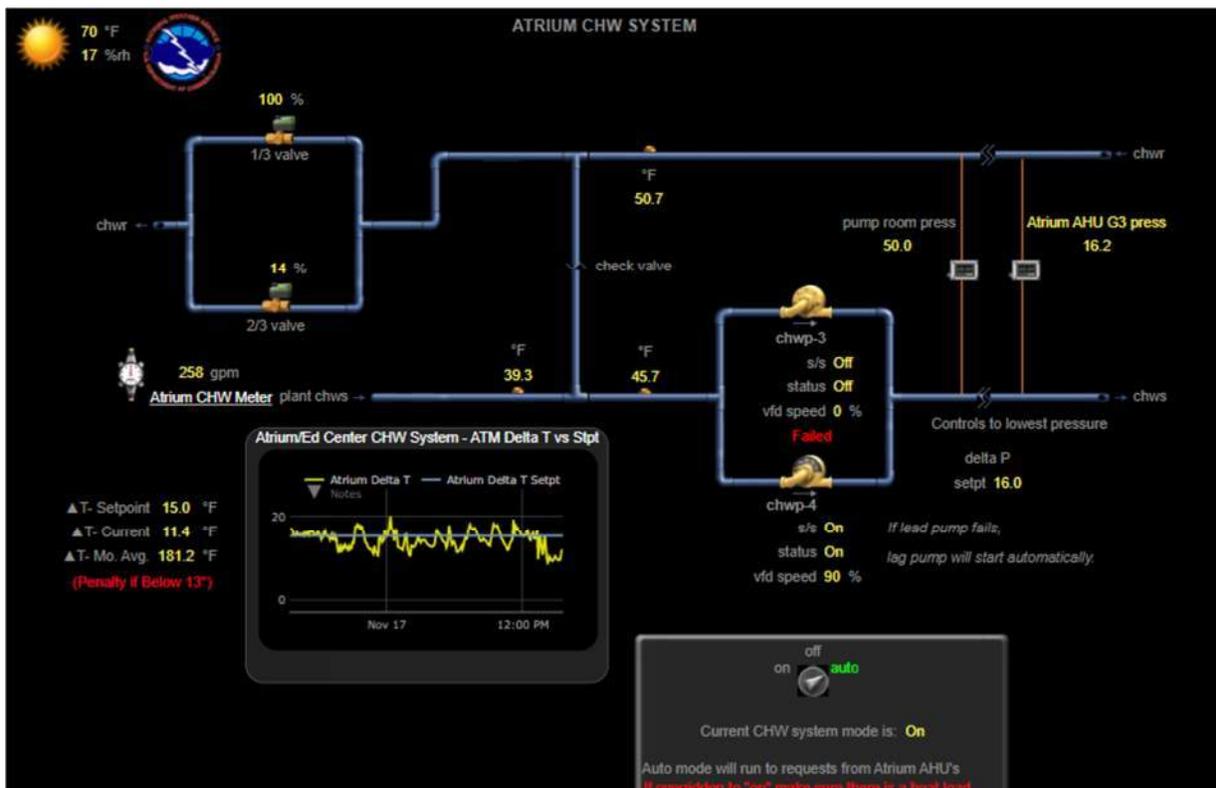
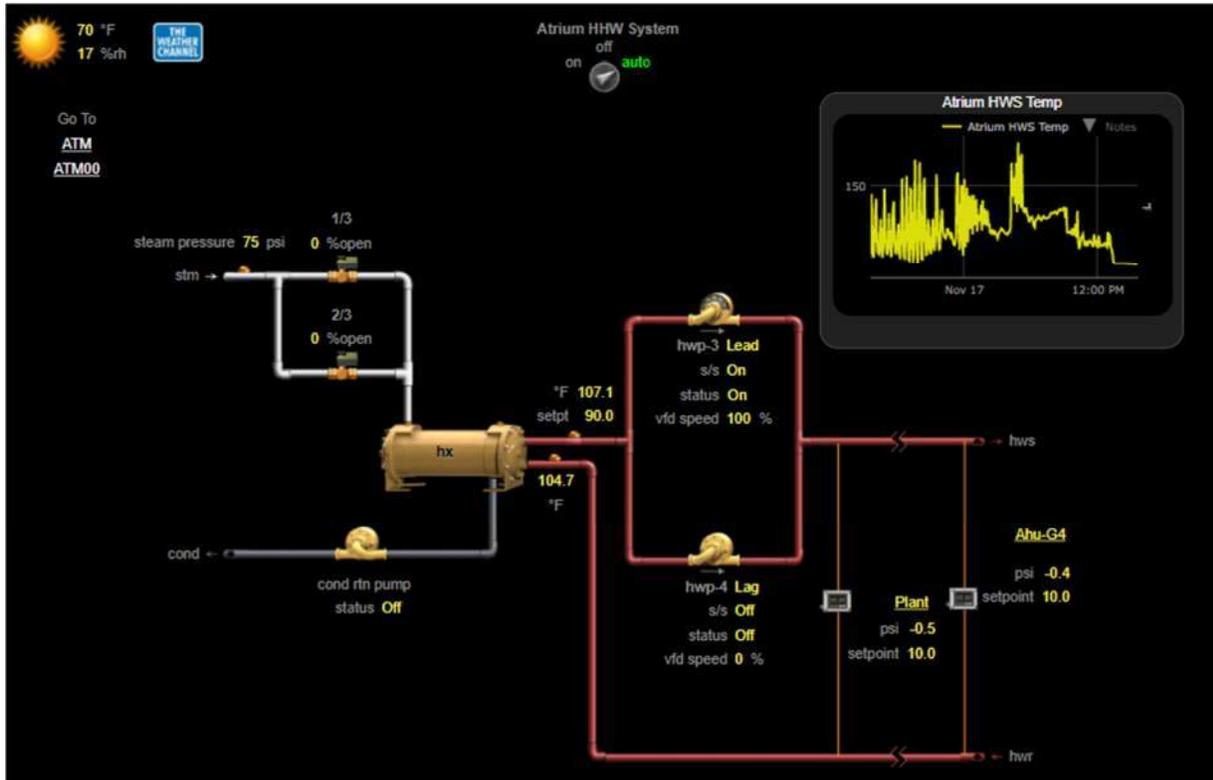
The ALC WebCTRL EMCS indicated that chilled water and hot water is provided to the Atrium's HVAC systems from the same pumping system that was evaluated for the Samis Education Center building. See the Samis Education Center building report for more information about the current operations of the Atrium chilled water and hot water distribution systems.

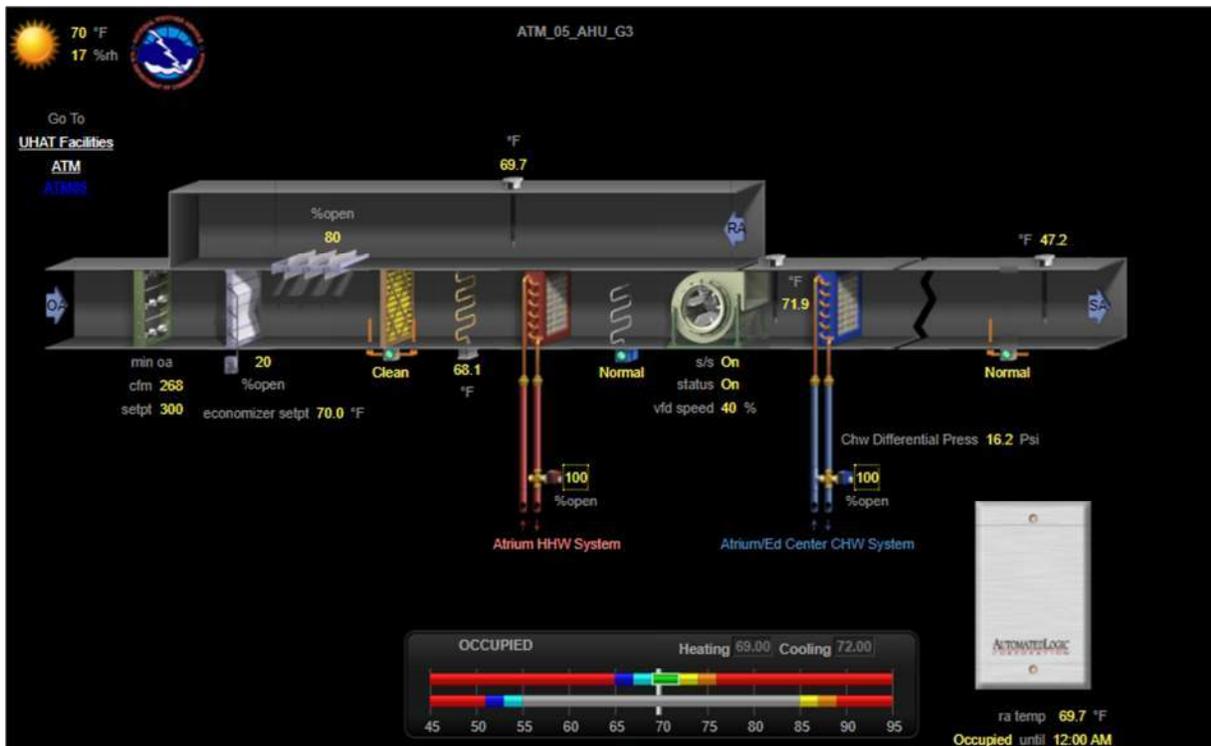
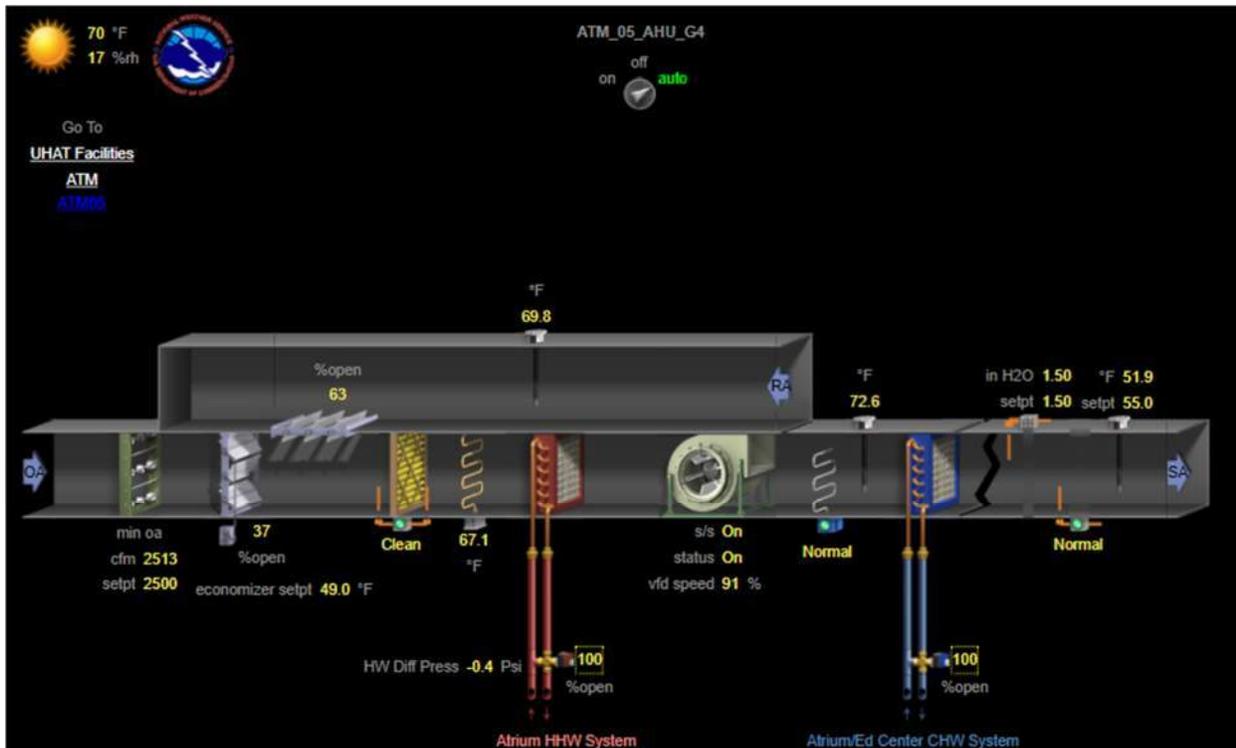
In addition, it was observed that the chilled water and hot water valves at times will work against each other's load requirements. In the BAS screenshots below. Both the chilled water and hot water valves were observed to be open at 100% despite the outside air conditions being at 70 degF and 17% RH, in order to provide a 47 degF supply air temperature. Chilled water and hot water valves should be locked closed (0% open) once outside air temperatures reach high enough or low enough values to allow supply air temperature temperatures to be reset efficiently with outdoor air.

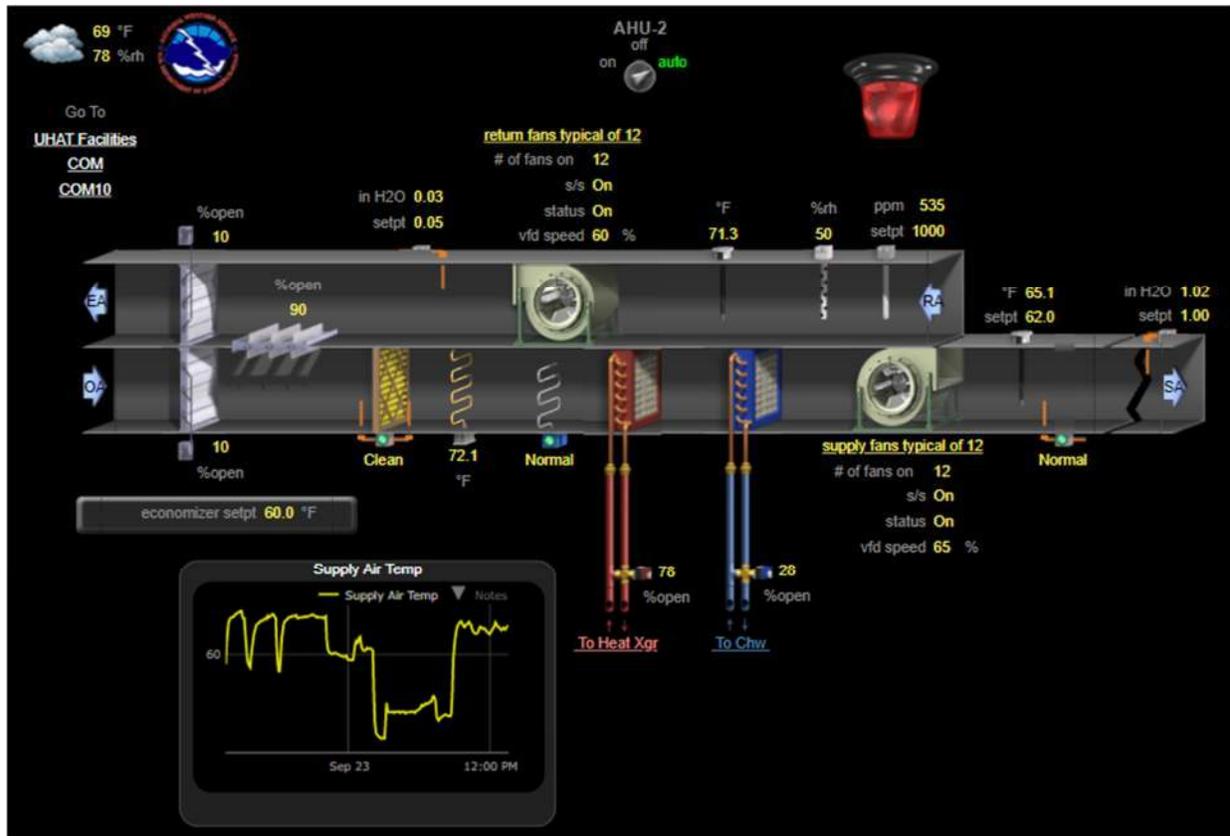
The EMCS similarly indicated that AHU-2 was operating with simultaneous heating and cooling with the heating hot water valve open 78% and the chilled water open 28%. The heating hot water coil is in the pre-heat position.

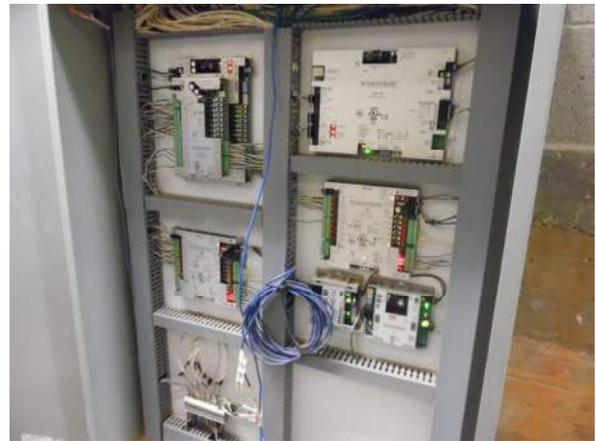
Photo #10 Terracon observed Automatic Logic Controls serving HVAC equipment in the College of Medicine Building.

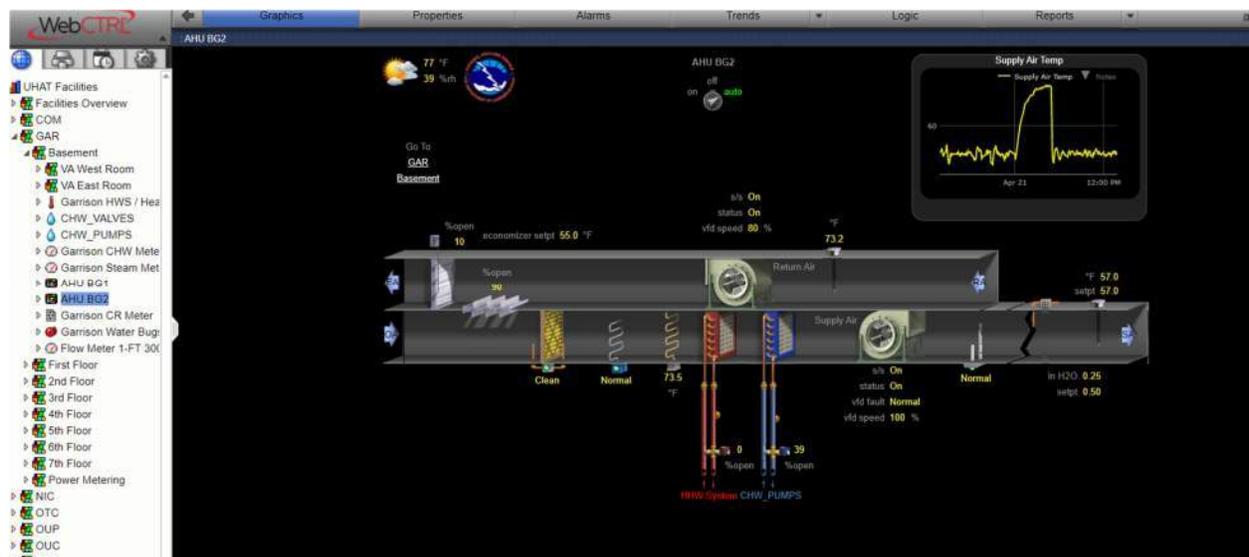
The ALC WebCTRL EMCS indicated that AHU BG2 was having issues maintaining static pressure setpoint (0.50" w.g.) when the fan speed of the supply air fan was operating at 100%. Supply air temperature setpoint is being met, but air pressure issues could be indicative of an obstruction (fouled coils or coil corrosion) or duct leak. An older unit, such as this one, may need a major overhaul or higher capital expenditure replacement priority in order to improve system performance.

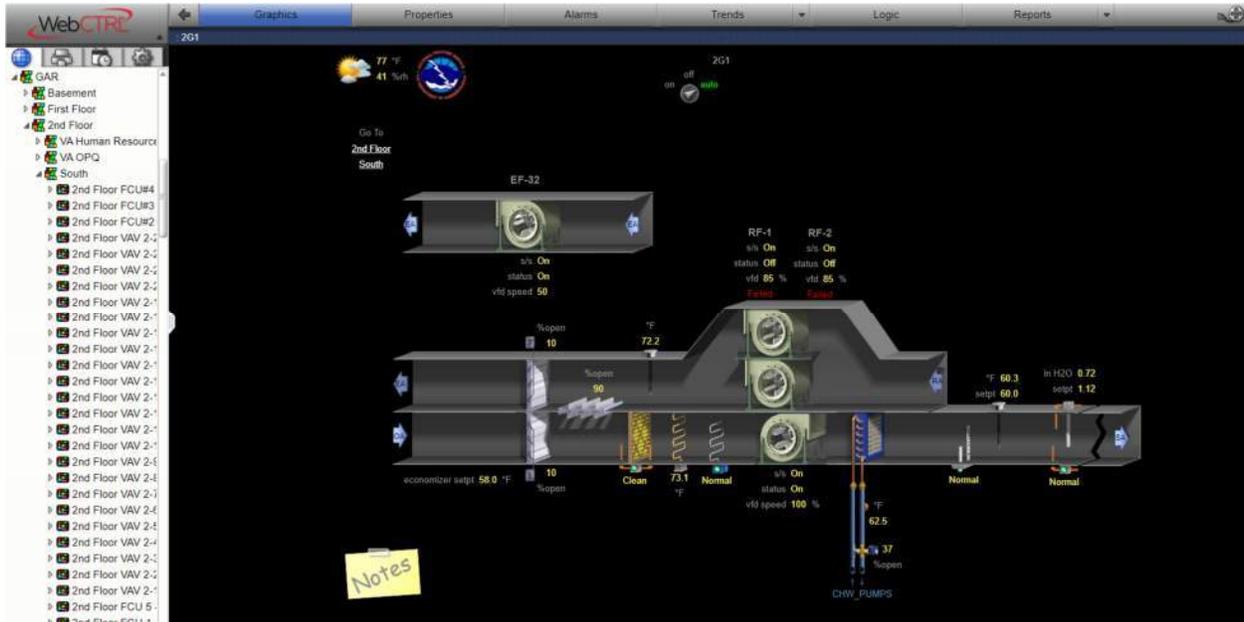
The EMCS also indicated that AHU 2G1 was having issues maintaining static pressure setpoint (1.12" w.g.) when the fan speed of the supply air fan was operating at 100%. In addition, the two relief/return fans appear to not be functioning. The supply fan may be operating at a higher speed to compensate for the lack of suction pressure from the relief/return fans. Areas being served by AHU 2G1 may have issues properly cooling and heating the space and may requiring extended operating periods than a system with a functioning relief/return fan system.

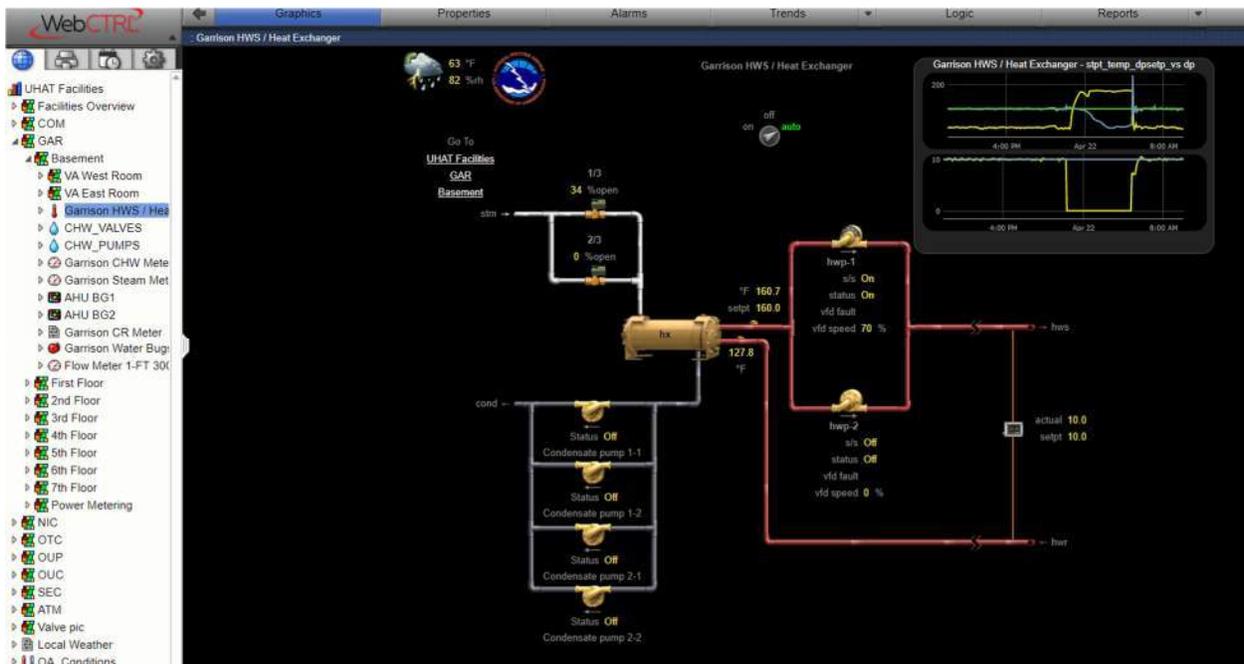
The steam-to-hot water heat exchanger for the heating hot water distribution was observed to be set for 160°F. Heating loads will vary as the weather changes and the building could benefit from a hot water temperature reset schedule. This may also be a contributor to the elevated annual steam energy consumption ratio for the building.

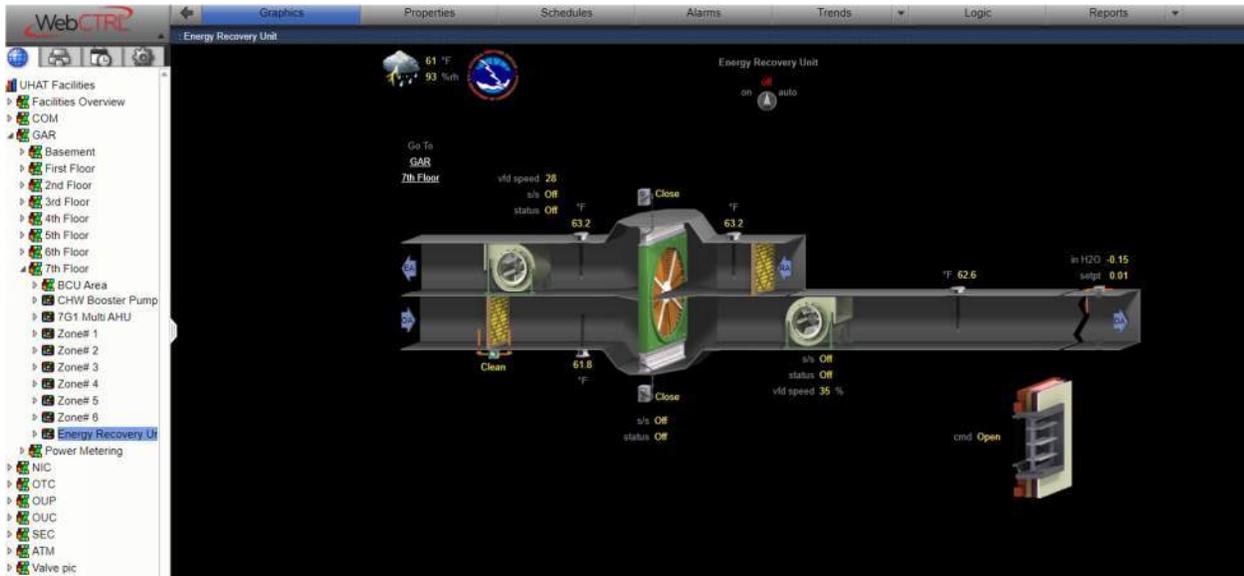
The EMCS indicated that the energy recovery unit (ERU) is not operational (exhaust and supply fans were not operating). The ERU appears to have at one time distributed outside air to many of the VAV AHUs. Outside air is still being distributed to the VAV AHUs, but without the use of the ERU fans. Since the building has been reclassified from an inpatient healthcare building to an administrative healthcare facility with minimal outpatient services, there is no need to fully utilize the ERU's ventilation capabilities. However, a reduction in outside air based on CO2 levels may provide reduced energy consumption.

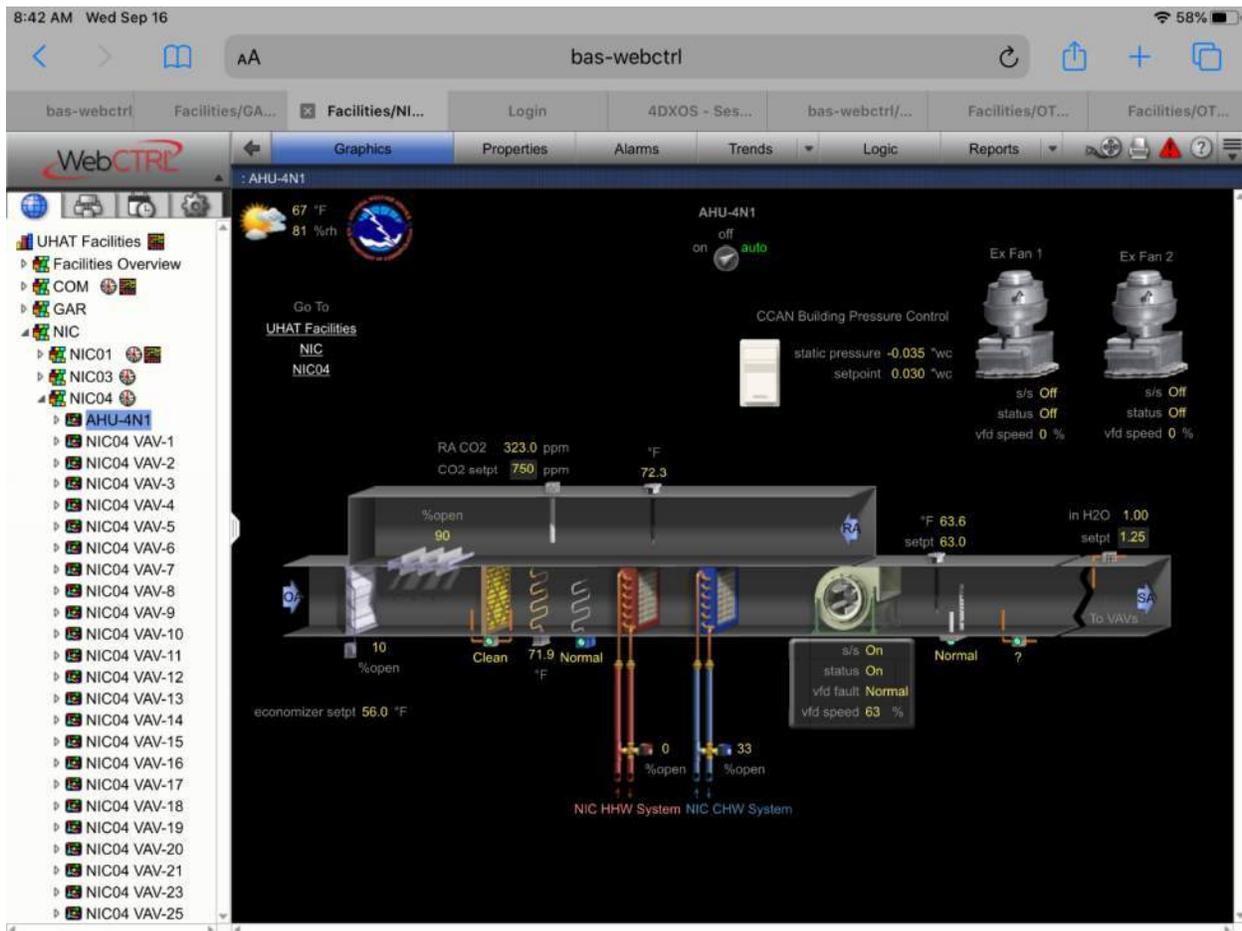
The *ALC WebCTRL* EMCS indicated that AHU 4N1 was having issues maintaining static air pressure setpoint (1.25" w.g.) when the fan speed of the supply air fan was operating at 63%. Supply air temperature setpoint was being met, but static air pressure issues could be indicative of an obstruction (fouled coils or coil corrosion) or duct leakage. The exhaust fans in the mechanical room with AHU 4N1 were off with the outside air damper slightly open at 10%, causing a significant amount of negative pressure in the mechanical room from the return plenum.

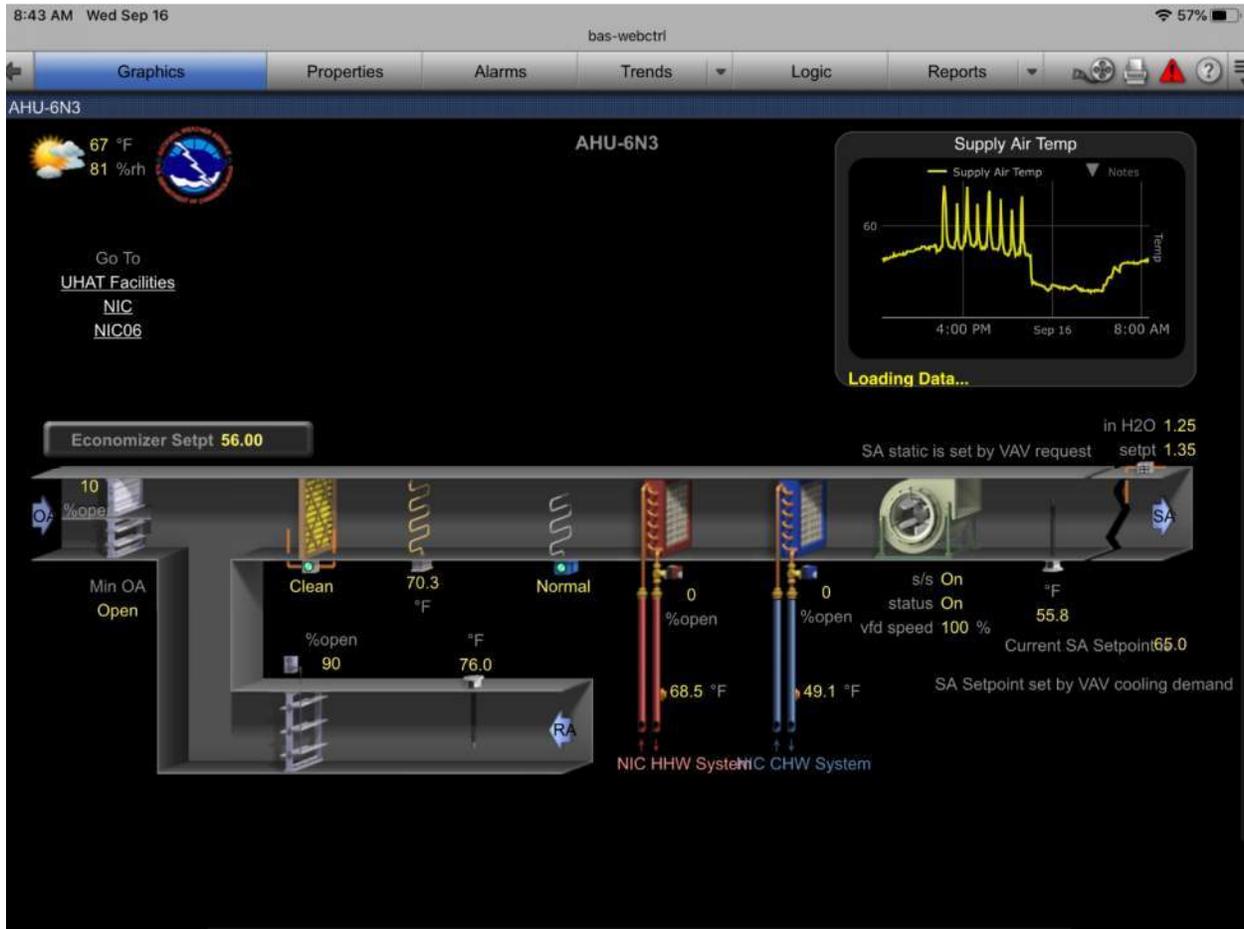
The ALC WebCTRL EMCS indicated that AHU 6N3 was having issues maintaining static pressure setpoint (1.35" w.g.) when the fan speed of the supply air fan was operating at 100%. Supply air temperature setpoint was being met, but static air pressure issues could be indicative of an obstruction (fouled coils or coil corrosion) or duct leakage. The AHU serves the majority of the VAV TB's on the fifth floor. An older unit, such as this one, may need a major overhaul or higher priority for capital expenditure replacement in order to improve system performance.

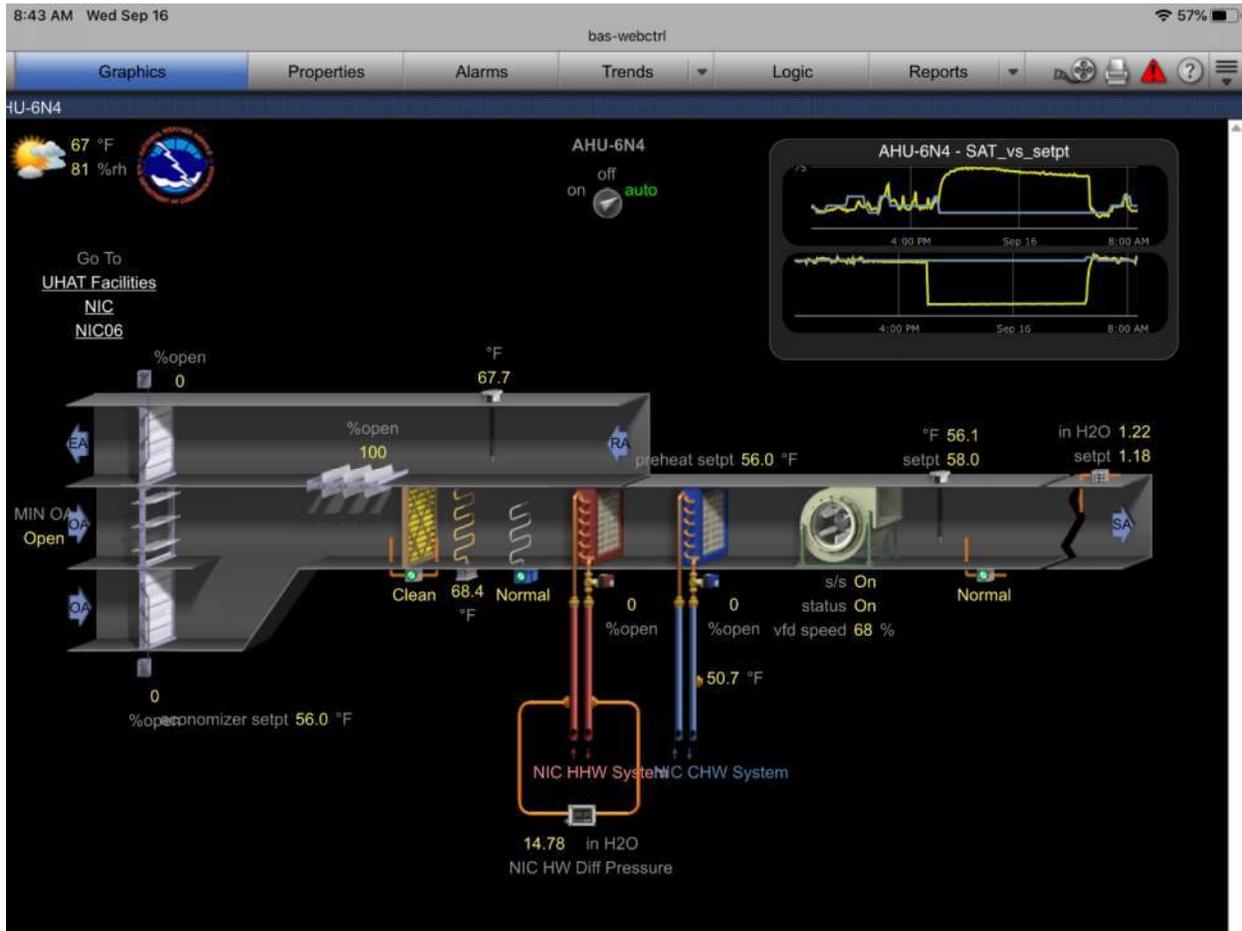
The EMCS also indicated that AHU 6N4 was having issues bypassing chilled water for the chilled water coil when the chilled water control valve was 0% open. The AHU was providing a discharge air temperature lower than the mixed air temperature despite the chilled water control valve being at 0% open.

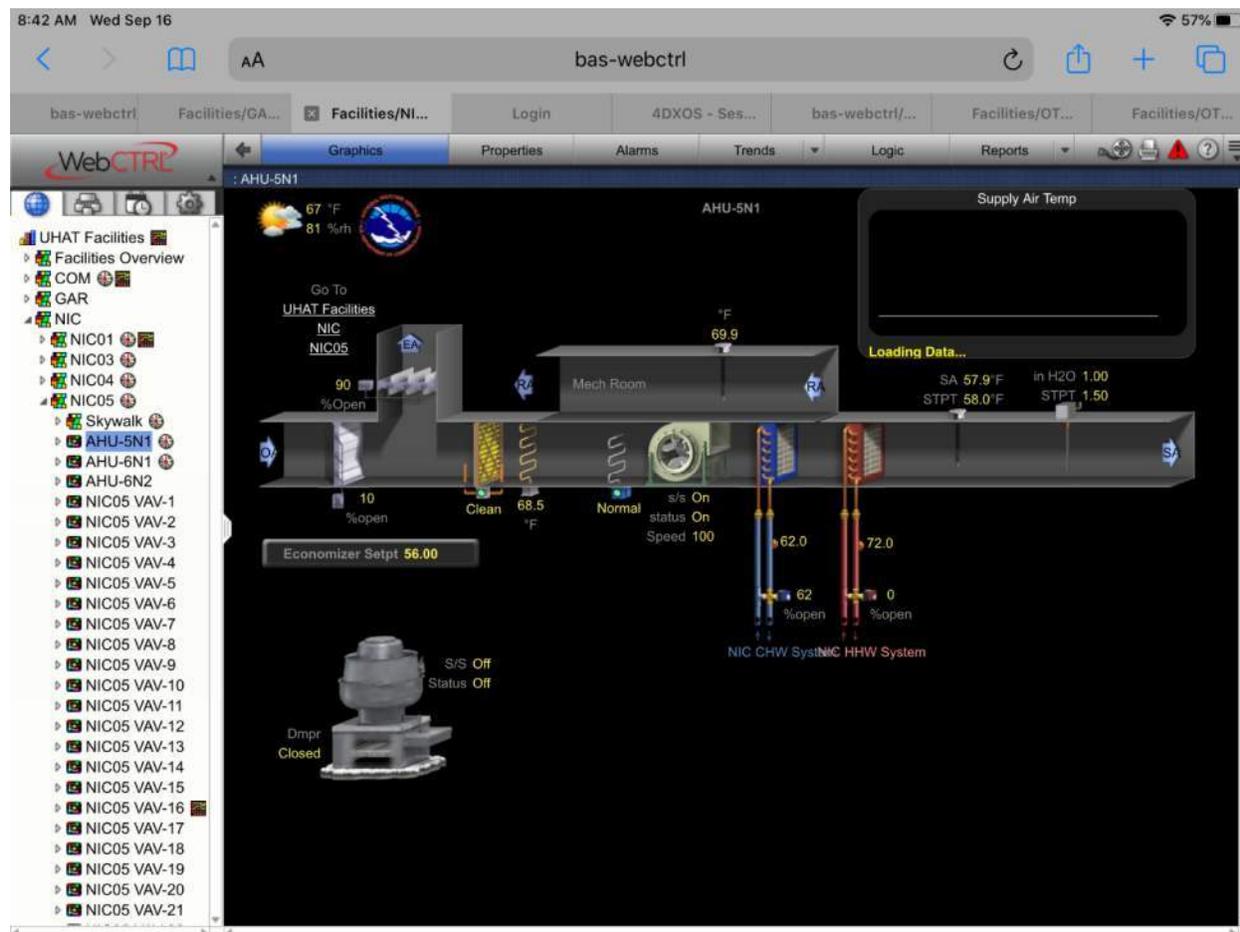
The EMCS also indicated that AHU 5N1 was having issues maintaining static air pressure setpoint (1.50" w.g.) when the fan speed of the supply air fan was operating at 100%. In addition, the exhaust fan system on the same controller as AHU 5N1 does not appear to be operating, even though the dampers indicate only minimum outside air if being provided. The entering chilled water temperature being measured with the EMCS also indicated that chilled water is being provided at a greater temperature than the discharge air temperature for AHU 5N1. The sensor may be incorrectly monitoring the leaving water temperature instead of the entering water temperature or the sensor may be reading incorrectly, causing the chilled water control valve to open excessively. Independent measurements from the BAS, indicate the entering and leaving temperatures of the chilled water coil are within the generally expected range that the chilled water distribution system is providing to the building.

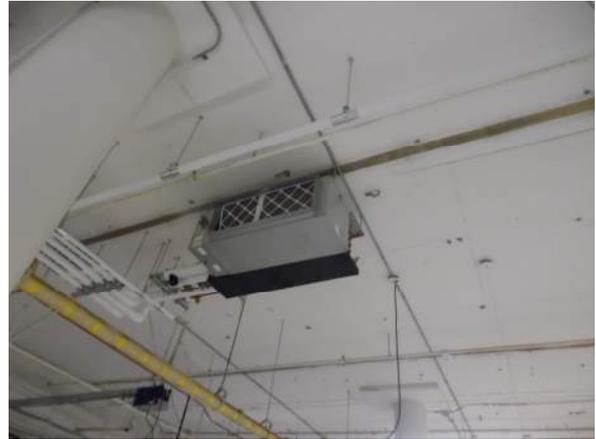
Photo #2 FCU serving the first floor four pipe system. This floor is being used for storage during an on-going renovation.

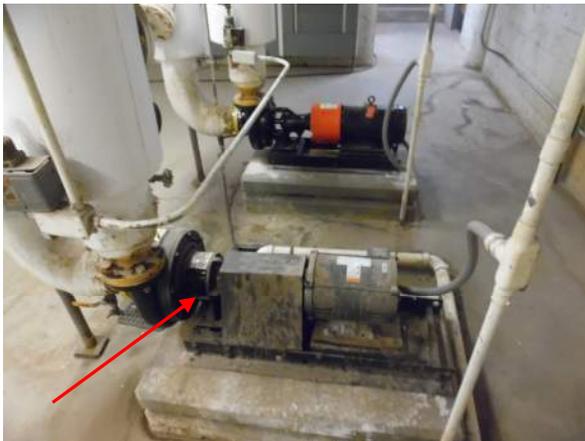
Photo #3 Heating Hot Water Distribution Pump #2 has noisy bearings and should be repaired.

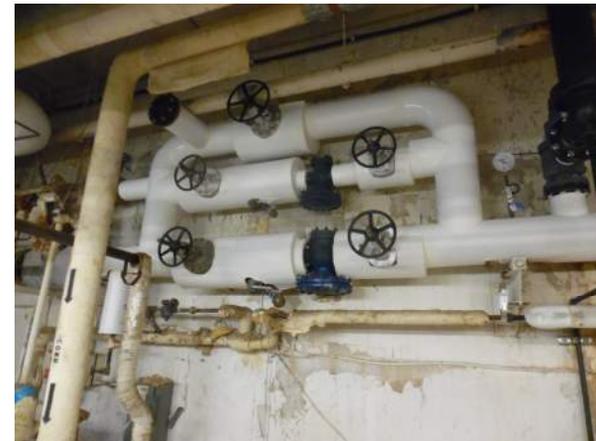
Photo #4 New steam piping, valves and usage meters were being installed at the Nicholson Tower.

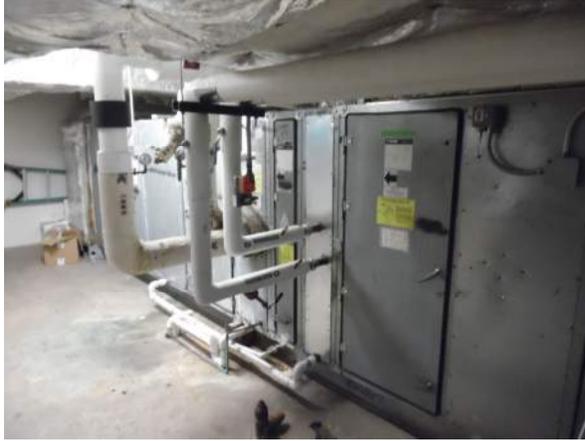
Photo #13 AHU 3N4 is a *TRANE* unit manufactured in 1994 that appears to have had the steam coils replaced by hot water coils.

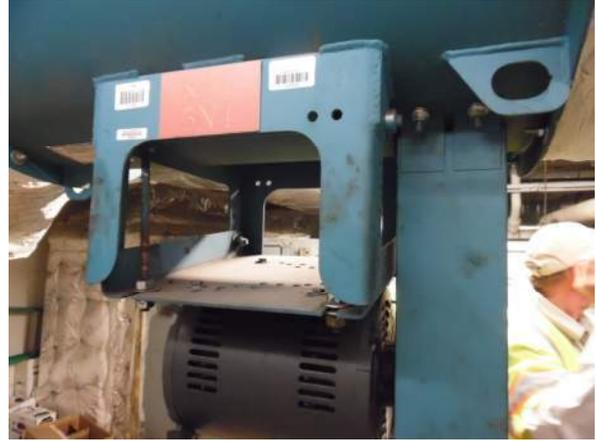
Photo #14 Separate supply and return air fans are used for AHU 3N4 on the third floor.

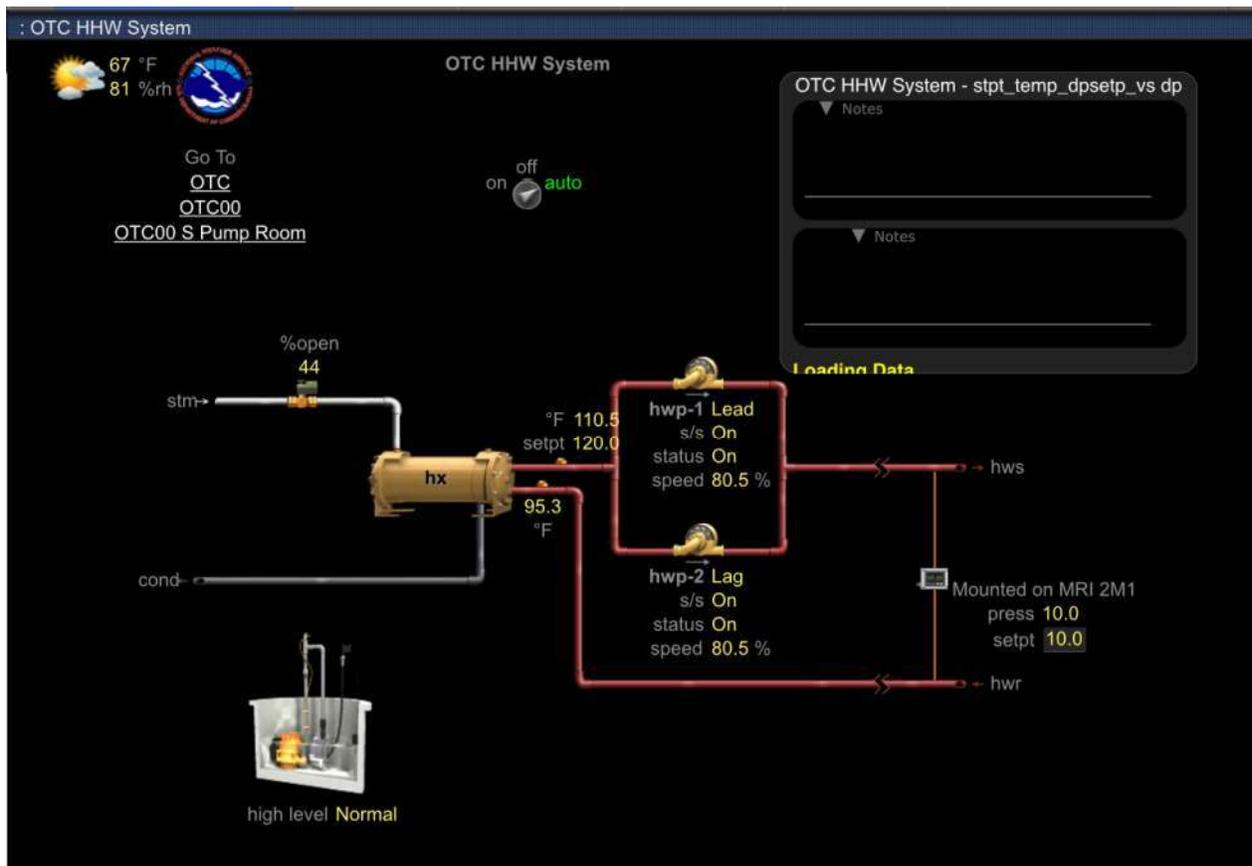
HHW System

The *ALC WebCTRL* EMCS indicated that both heating hot water pumps were operational at 80.5% speed in the morning when the outdoor air temperature was comparable to the indoor temperature and the building was expected to have minimal heating load, and no AHUs were calling for heating hot water. This could be indicative of poor heat transfer for heating coils, valve leak-by/bypass, or excessive differential pressure setpoint in the distributed heating hot water piping.

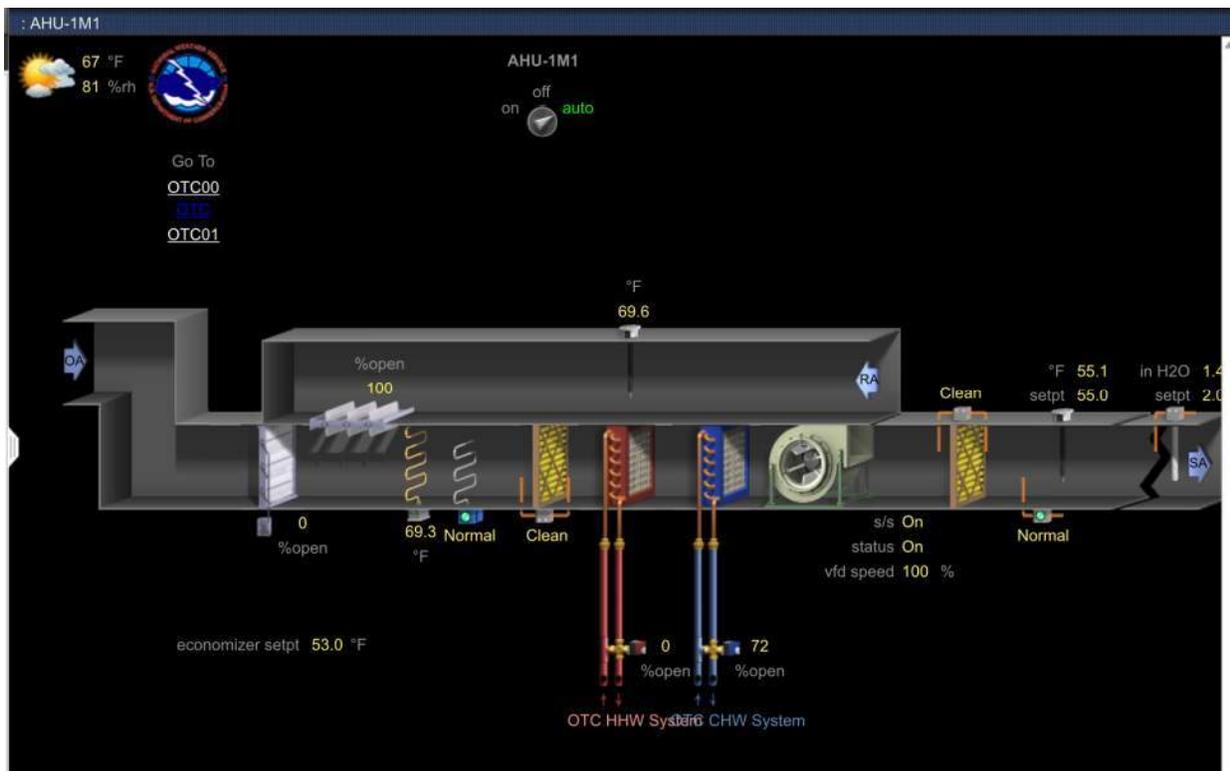
AHU-1M1

Terracon observed AHU 1M1 as having an air static pressure setpoint of 2.0 in.w.g., but only measuring a pressure of 1.4 in.w.g. The system fan speed was operating at 100% during a period where the outdoor conditions were minimally requesting cooling. This is most likely caused by a lack of air flow across the chilled water and heating hot water coils. Previous notes and measurements taken by ES2 in 2010 indicated that air flow was difficult to measure and static pressure between coils was significantly high due to both water coils being covered in construction dust. More recent measurements in December 2020 were taken via a *Velgrid* inside the AHU across the face of the coil to measure air flow across the coils, since access to measure discharge air was difficult.

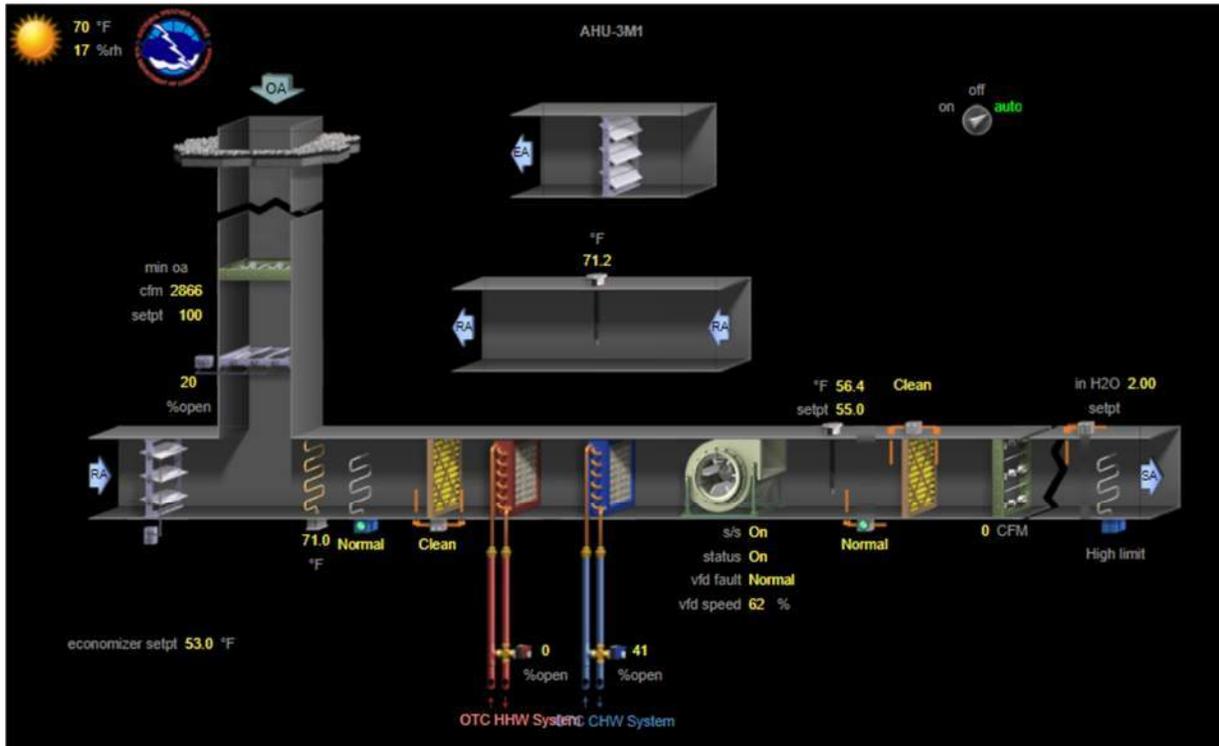
AHU-3M1

Terracon also observed AHU 3M1 in operation without a discharge air flow static pressure setpoint indicated on the BAS graphics page. The air flow indicated a measured static pressure of 2.0 in.w.g. This may indicate that discharge air flow of the AHU is being operated independent to the air flow demand required by the VAV TBs. The opportunity to reset air flow to a lower speed during shoulder periods of the year (spring and fall) when the cooling and heating loads are lower than peak periods may be available with a number of programming updates.

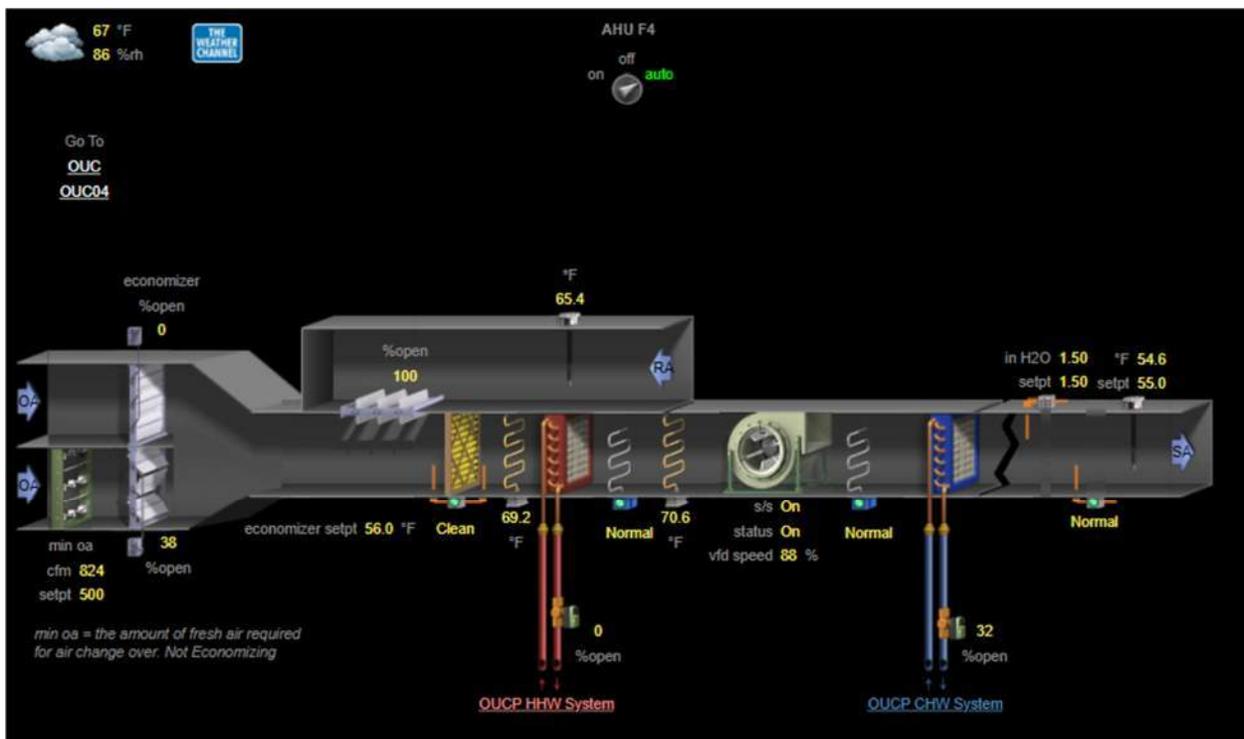
AHU F4

The AHU is designed to operate with a minimum amount of outside air when the EF is operating at constant speed as designed for the space to have a slight positive air pressure. The combination of the AHU providing less than the minimum amount of outside air as designed and the EF operating at constant speed may be impacting the 4th Floor creating negative air pressurization.

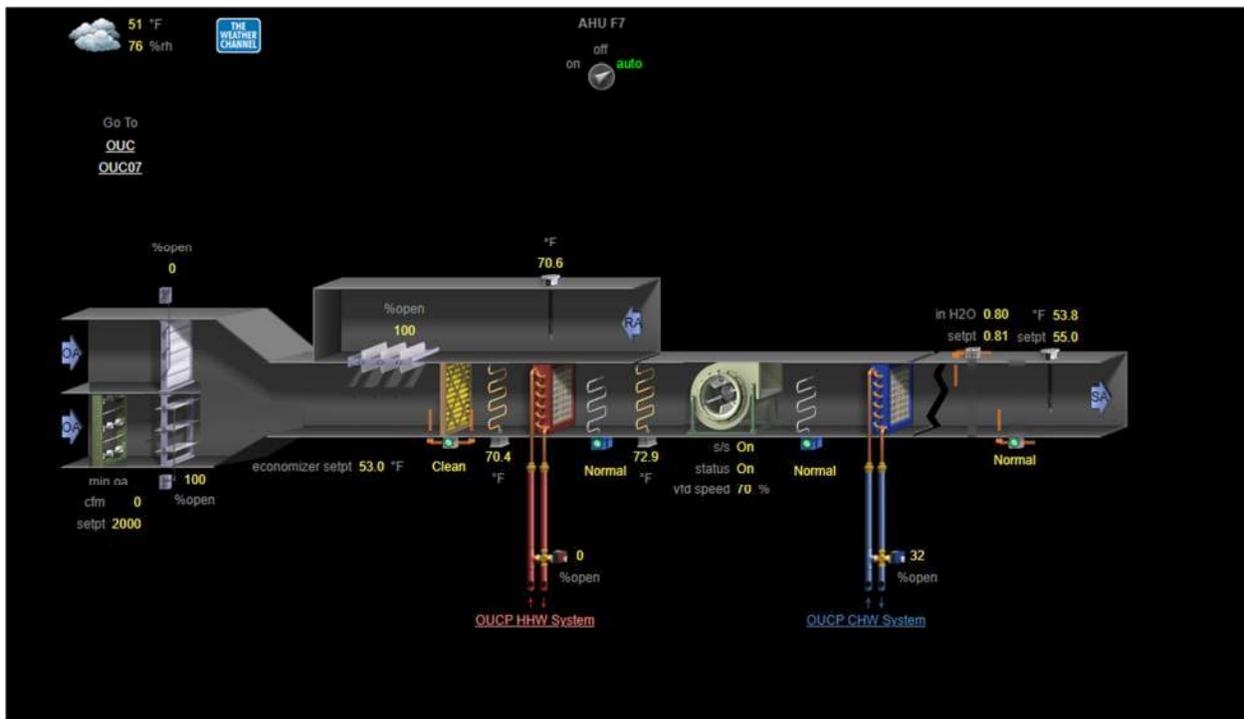
AHU F7

The AHU, RF, and EF are designed to operate in the control sequence to provide the 7th floor with a slightly positive air pressure. The combination of the AHU providing less than the minimum amount of outside air as designed, the RF and EF each operating at 100%, and the VF operating at constant speed may all be impacting the 7th Floor by creating negative air pressurization. The air differential pressure sensor indicated a static air pressure of +0.05 in w.g. It is likely the reference points (room pressure and adjacent room pressure) for the measurements of the floor are not installed correctly.

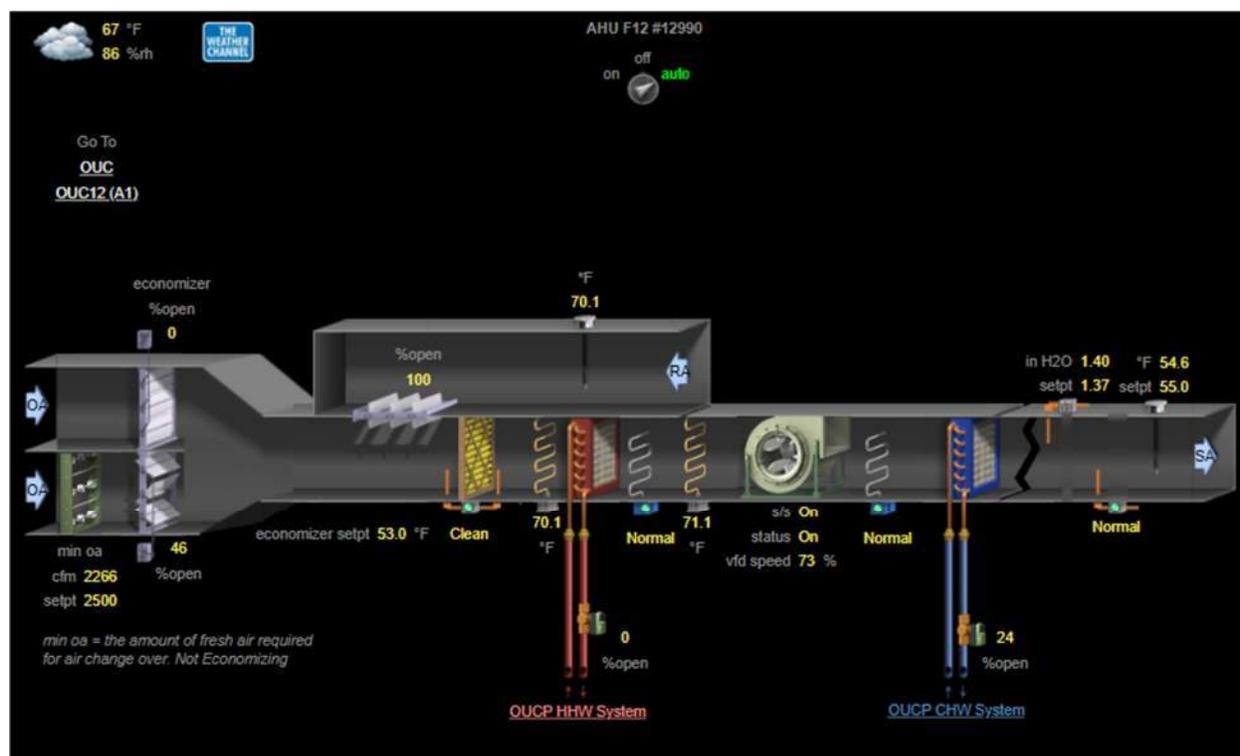
AHU F12

The AHU is designed to operate with a minimum amount of outside air when the EF is operating at constant speed for the 12th Floor to have a slightly positive air pressure. The AHU was observed to be providing less than the minimum amount of outside air as designed, but the EF was observed to be exhausting less air than the amount of outside air provided to the AHU as designed. The static pressure on the floor was observed to be -0.05 in w.g. when a positive static air pressure was expected to be recorded.

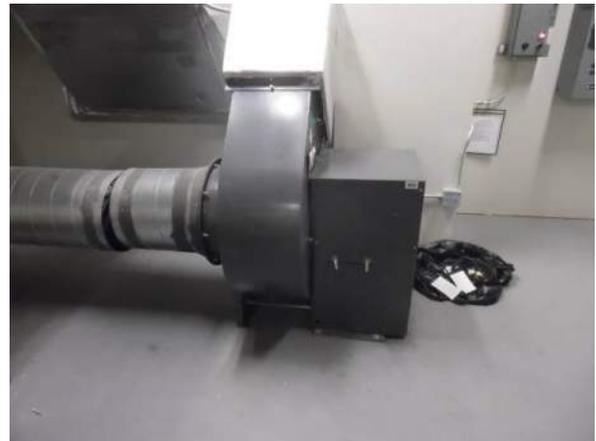
Photo #4 Typical constant volume exhaust fan serving each floor needed to achieve static air pressure design conditions.

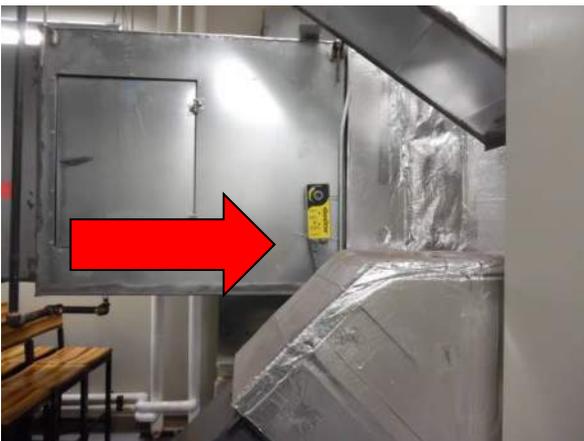
Photo #5 Typical relief fan with damper actuator for each floor necessary to achieve static air pressure design conditions when AHUs are in air economizer mode.
