Building Infrastructure Testing and Retro-Commissioning

Final Combined Report

Children's Atrium, OU Children's Physician Building, College of Medicine, OU Physician's Building, Garrison Tower, Nicholson Building, Oklahoma Transplant Center and Samis Education Center

Project No. FA20P031

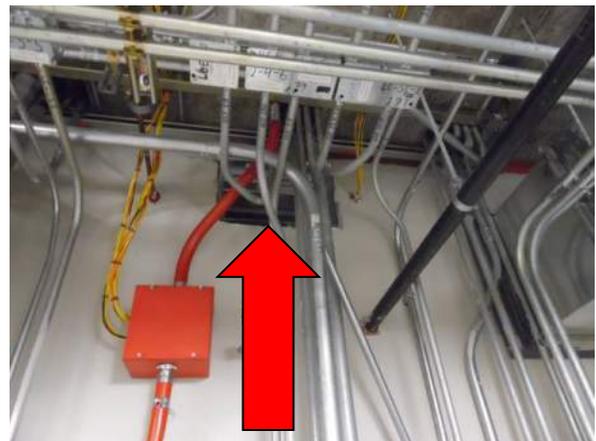
Photo #6 Typical fire and smoke dampers observed in return to each mechanical room.

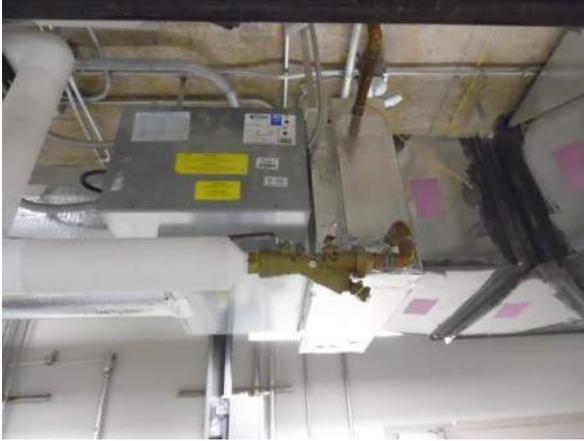
Photo#7 Typical Titus VAV box with reheat coil throughout the building.

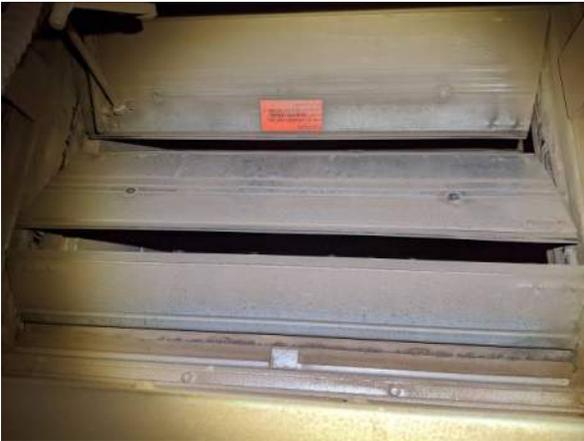
Photo #9 Typical condition of corroded and debris laden outside air dampers with airflow monitoring station.

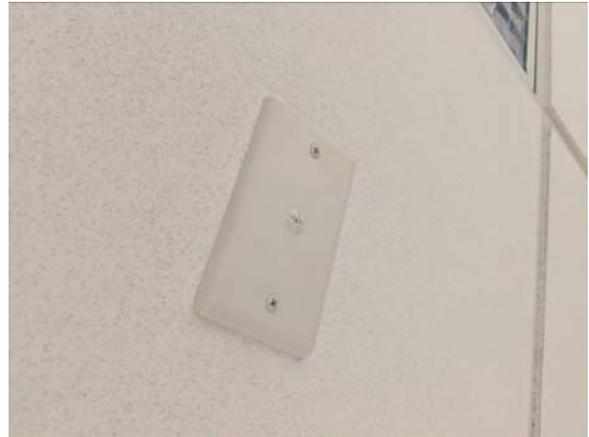
Photo #10 Typical ceiling-mounted air pressure sensor on each floor used to monitor and control static air pressure.

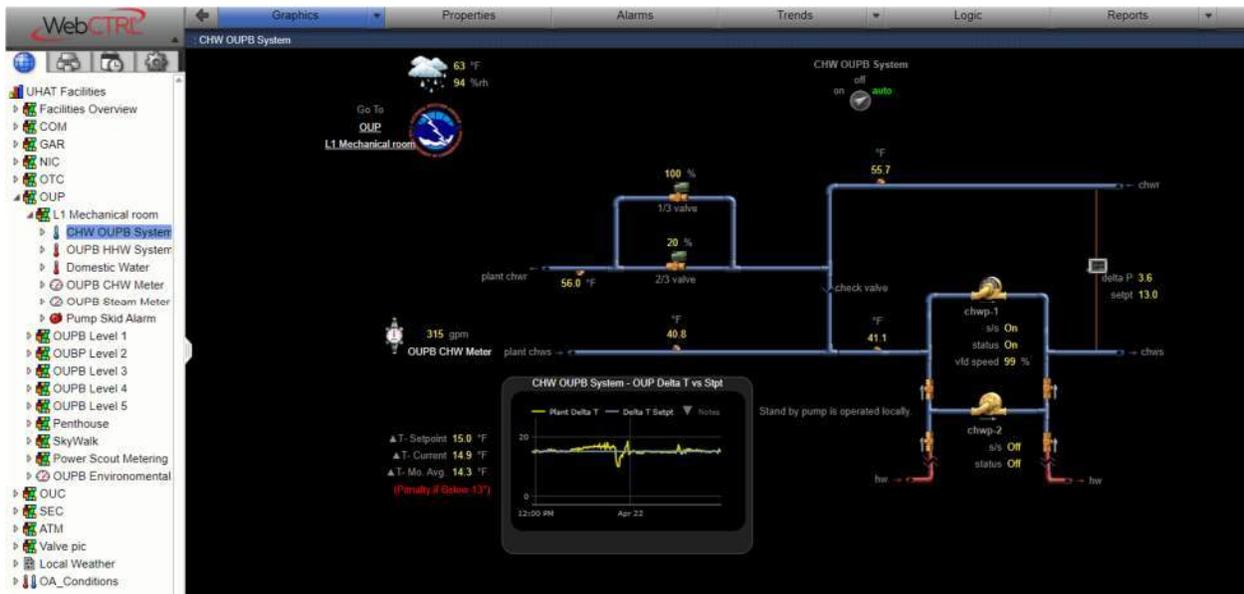
Terracon also observed conditions where the chilled water meter readings did not appear to be reasonable based on the chilled water pump speed and valve positions (percent open) of the 1/3 and 2/3 valves.

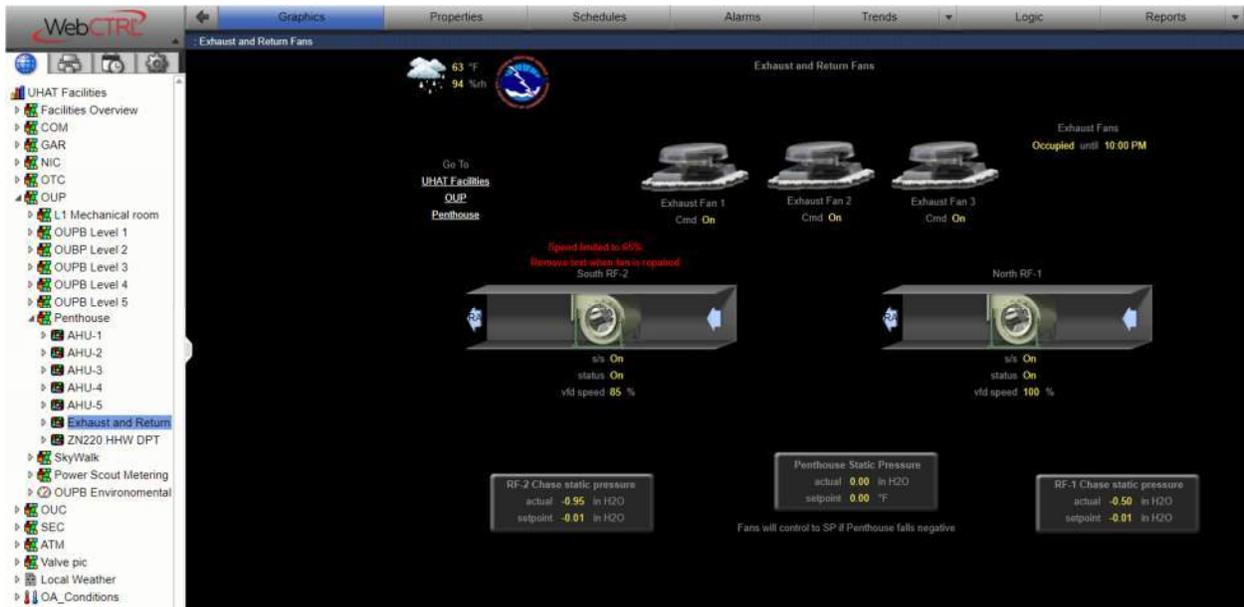
The EMCS indicated that the two return fans and four exhaust fans for the building were created a negative building air pressure condition. Information about the performance of the return fans was not indicated on the design drawings provided. A negative building air pressure effect, if significant enough, can cause unconditioned air to infiltrate the building envelope and place unnecessary heating and cooling loads on the building HVAC systems.

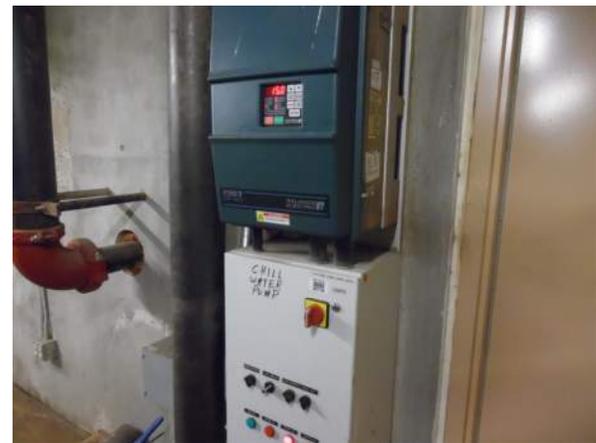
Photo #12 Defective chilled water VFD

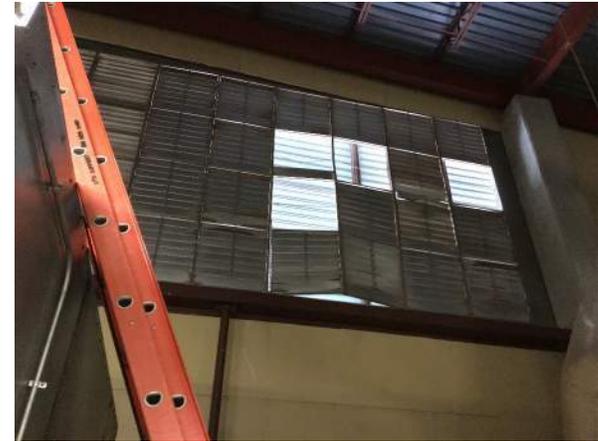
Photo #16 The gravity relief dampers need repair and or replacement.
